Manhole Inspection Summary

Manhole # S45I2_026MH

Insp Date: **6/20/08 2:07 PM**

Location Address: **1401 Church St.**

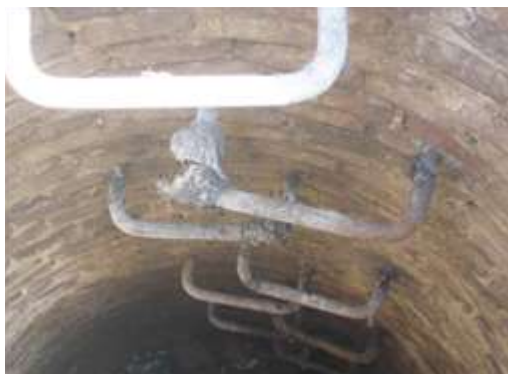
Steps Count: **8** Missing: **0** ☐ Corroded

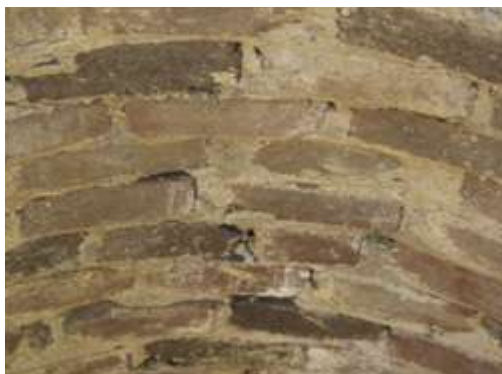
Defect 1

Condition: ☐ Sound ☒ **Cracked** ☐ Root Intrusion ☐ Loose Brick ☐ Deteriorated

Infiltration: ☐ None ☐ Joint ☐ Cracks ☐ Mortar ☐ Roots ☒ **Wall**

Cracked barrel

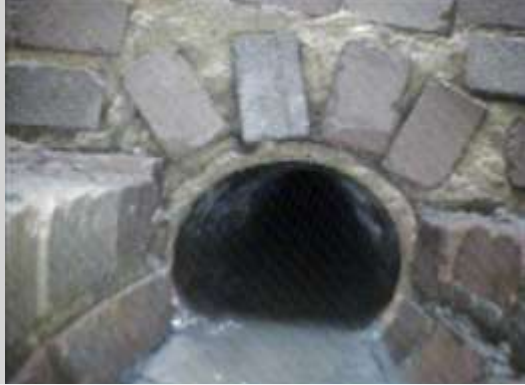
12 O'Clock Outflow

8 in. Circular Gravity Sewer
Pipe Out @ 12 O'Clock

Pipe Height: **8.4** (in.) Rod and Bar (Angled)
Pipe Material: **Clay** ☐ Pipe Lined
Invert Depth: **13.40** (ft.) Flow Characteristics: **Fast**
Deposits: ☒ None ☐ Mud ☐ Sludge ☐ Debris ☐ Grease
Silt Depth: (in.) Deposits Extent:
Infiltration: **None** Pipe Seal Cond: **Sound**

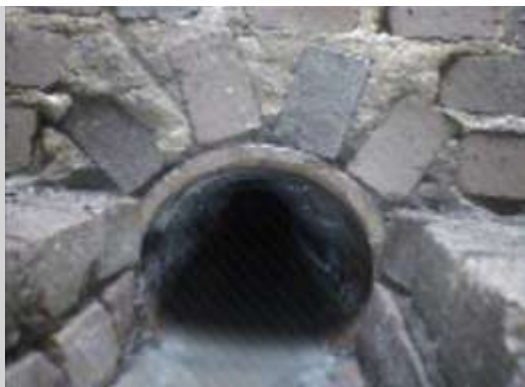
5 O'Clock Inflow

8 in. Circular Gravity Sewer
Pipe In @ 5 O'Clock

Pipe Height: **8.4** (in.) Rod and Bar (Angled)
Pipe Material: **Clay** ☐ Pipe Lined
Invert Depth: **13.36** (ft.) Flow Characteristics: **Fast**
Deposits: ☒ None ☐ Mud ☐ Sludge ☐ Debris ☐ Grease
Silt Depth: (in.) Deposits Extent:
Infiltration: **None** Pipe Seal Cond: **Sound**
